# 2017 BASIN HIGHLIGHTS REPORT

AN OVERVIEW OF WATER QUALITY THROUGHOUT THE  
CANADIAN AND RED RIVER BASINS

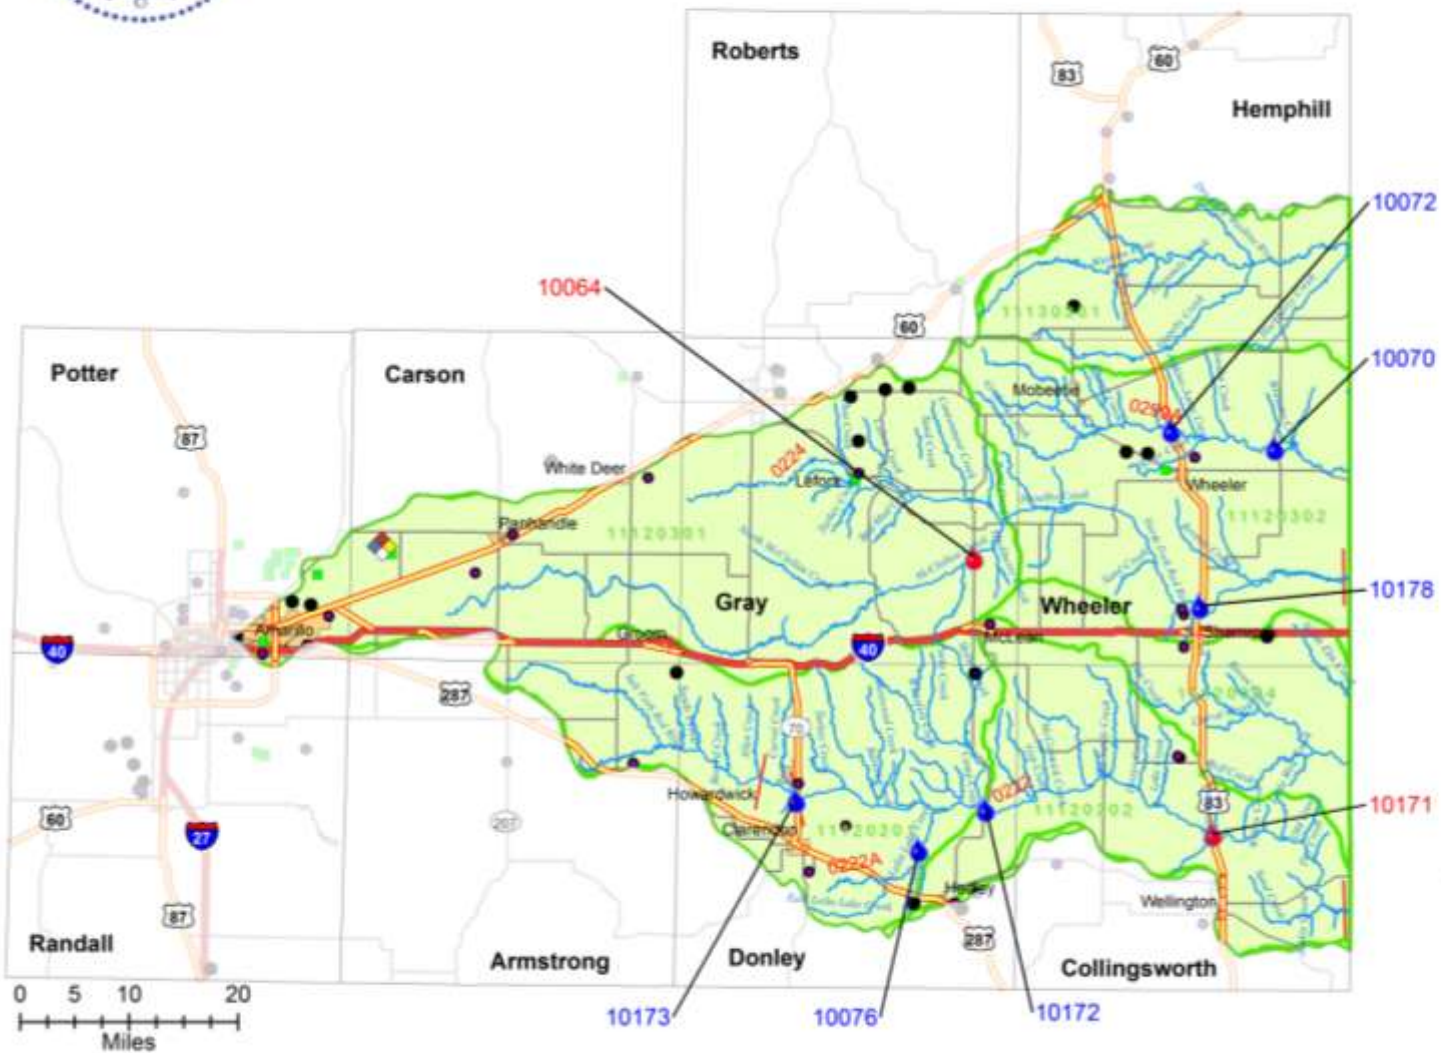
## Red River Basin Reach V

- Impaired MS
- Non-impaired MS
- Outfall
- Landfill
- Superfund Site
- CAFO
- Segment ID
- Segment Boundary
- Hydrology
- Urbanized Area
- County Boundary
- HUA Boundary
- Red Reach V

## **REACH V** (Refer to map on page 45)
